NUTORK CORP.

Sample Description : LIMIT SWITCHBOX
SGS Ref No. : GZIN1512056728MR
Style / Item No. : NTS-CPXX
Sample Receiving Date : Dec. 29, 2015
Test Performing Date : Dec. 29, 2015 to Jan. 7, 2016
Test Performed : Selected test(s) as requested by applicant
Test Result(s) : For further details, please refer to the following page(s)

Summary of Results:

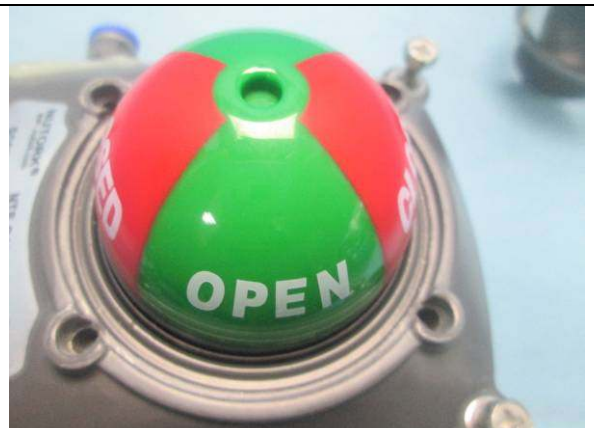
After test (Sample 1) - Local part

Sample	Result
1	No ingress of dust

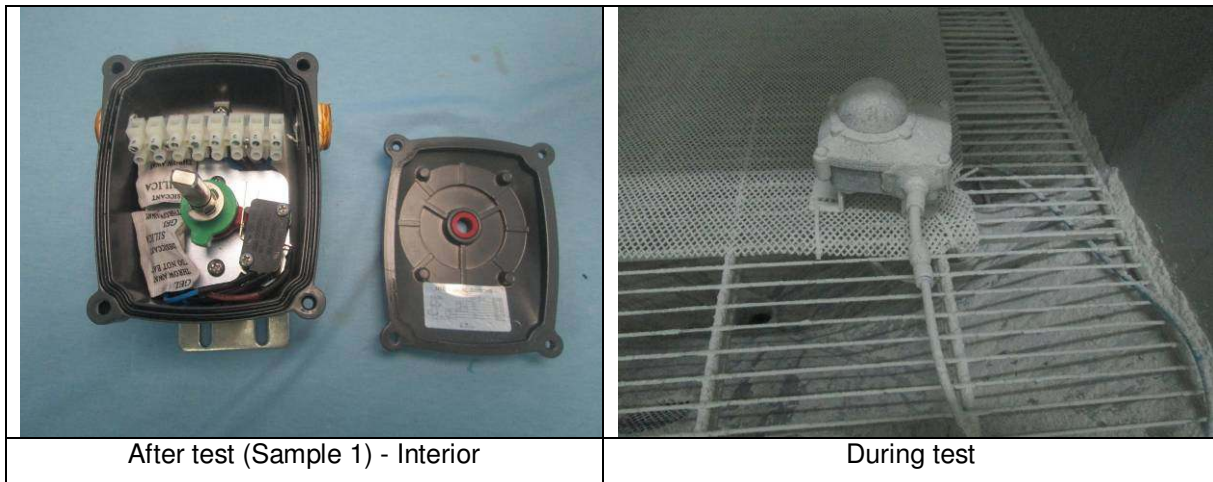
After test (Sample 1) - Interior

During test

Test Dust: Talcum powder

Dust Concentration: 2 kg/m³ chamber volume and be kept in suspension during the test

Depression: 2 kPa

Test Duration: 8 hours

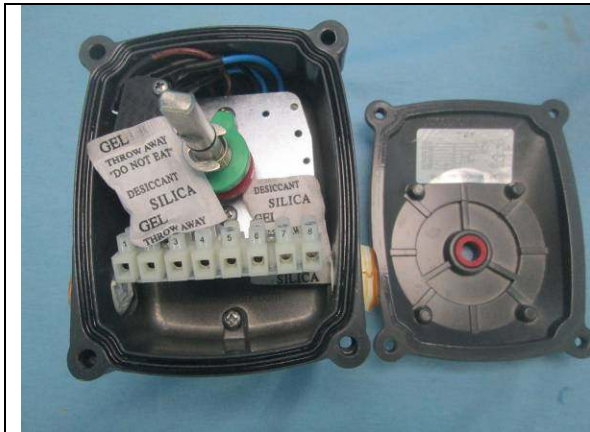
After test (Sample 2) - Interior

Sample	Result
2	No ingress of water
