NUTORK CORP

Sample Description : 1、(LOW TEMPERATURE EX-PROOF TYPE LIMIT SWITCHBOX),
2、(LOW TEMPERATURE EX-PROOF TYPE SOLENOID VALVE),
3、(LOW TEMPERATURE AIR PILOT VALVE),
4、(LOW TEMPERATURE AIR FILTER REGULATOR),
5、(LOW TEMPERATURE QUICK EXHAUST VALVE),
6、(LOW TEMPERATURE INTEGRAL MOUNTED AIR PILOT VALVE+SOLENOID VALVE),
7、(LOW TEMPERATURE PNEUMATIC ACTUATOR)

SGS Ref No. : GZIN1710047682MR

Style / Item No. : 1、NTS-KL2X, 2、SVX10F(P)1C5(4)-LT, 3、AOV-0X-LT, 4、AFR30-0X-LT, 5、QEV-0X-LT, 6、AOV-0X+SV-LT, 7、NKD(S)-XXX-LT

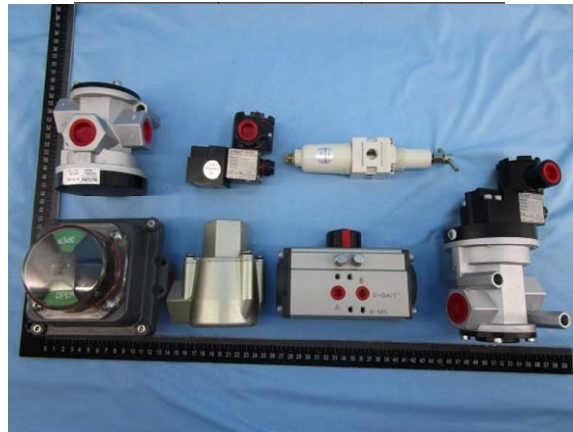
样品 A,B,C,D,E,F,G

Original Sample Photo:

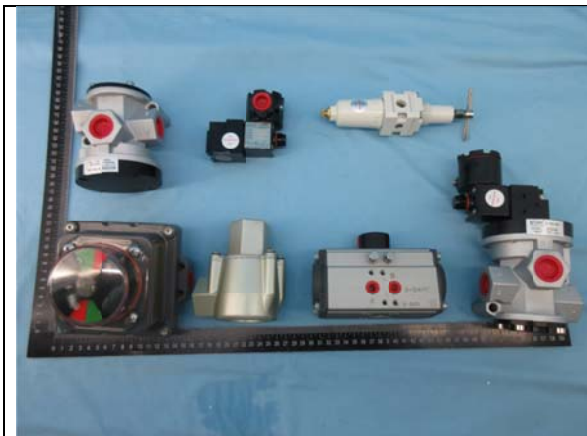
Temperature: -60°C

Duration: 72 hours

Sample	Result
A,B,C,D,E,F,G	No visible change on the samples

After test

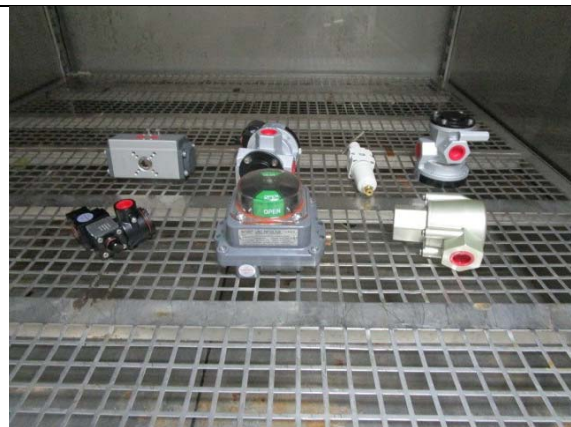
During test

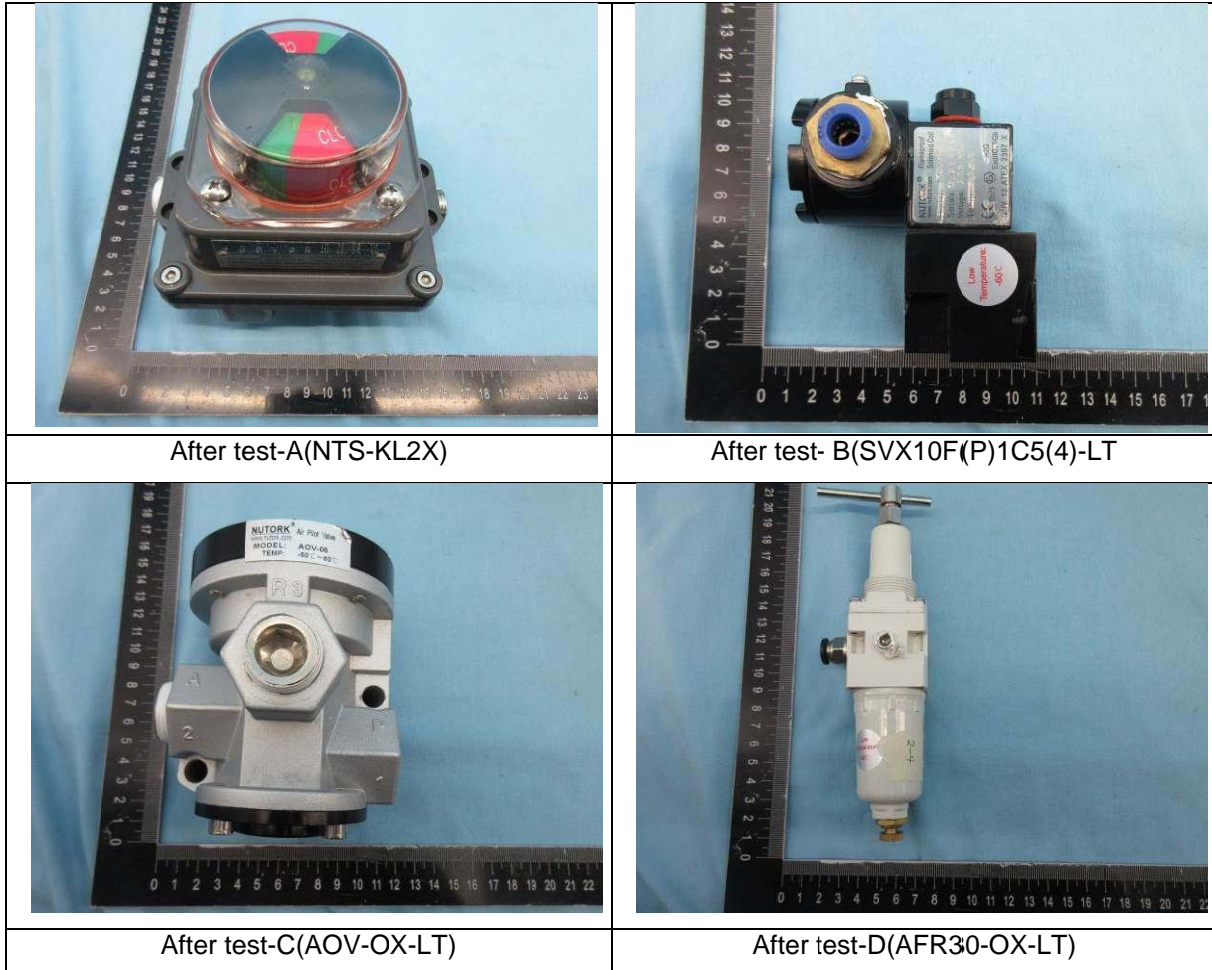
Test condition: Smear the suds on the samples and observe if there is a leakage on the surface

Sample	Test result
A(NTS-KL2X)	No visible bubble on the samples, no air leakage
B(SVX10F(P)1C5(4)-LT)	No visible bubble on the samples, no air leakage
C(AOV-OX-LT)	No visible bubble on the samples, no air leakage
D(AFR30-OX-LT)	No visible bubble on the samples, no air leakage
E(QEV-OX-LT)	No visible bubble on the samples, no air leakage
F(AOV-OX+SV-LT)	No visible bubble on the samples, no air leakage
G(NKD(S)-XXX-LT)	No visible bubble on the samples, no air leakage

Test Photo:

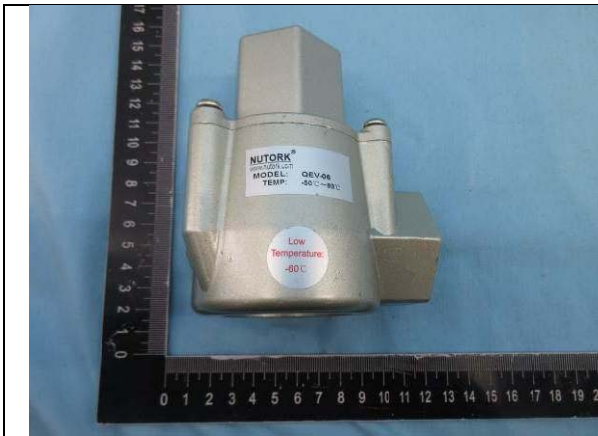
After test-E(QEV-OX-LT)

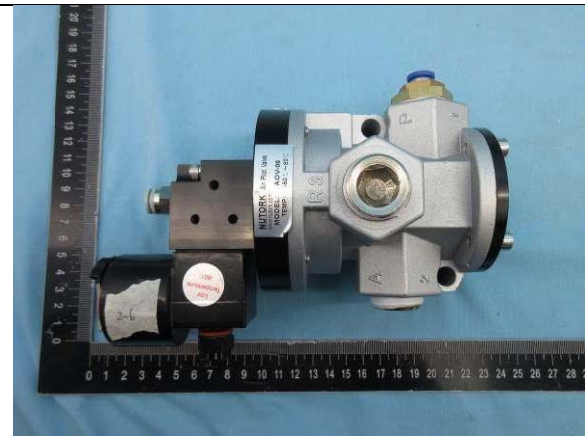
After test-F(AOV-OX+SV-LT)

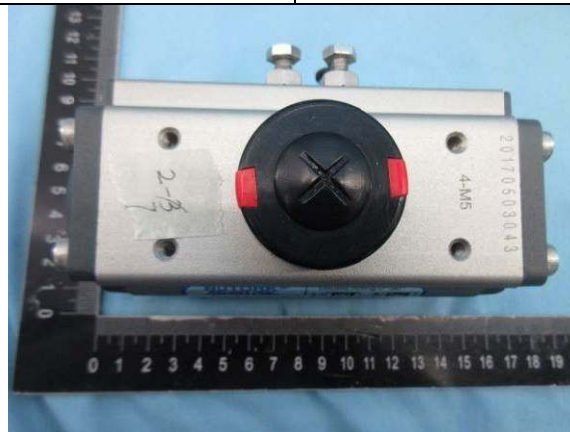
After test-G(NKD(S)-XXX-LT)
