NUTORK CORP

Sample Description : 1、 (LOW TEMPERATURE EX-PROOF TYPE LIMIT SWITCHBOX),  
2、 (LOW TEMPERATURE EX-PROOF TYPE LIMIT SWITCHBOX),  
3、 (LOW TEMPERATURE SOLENOID VALVE)

SGS Ref No. : GZIN1710047677MR

Style / Item No. : 1、 NTS-KLXX, 2、 NTS-HLXX, 3、 SV310F3CX-LT

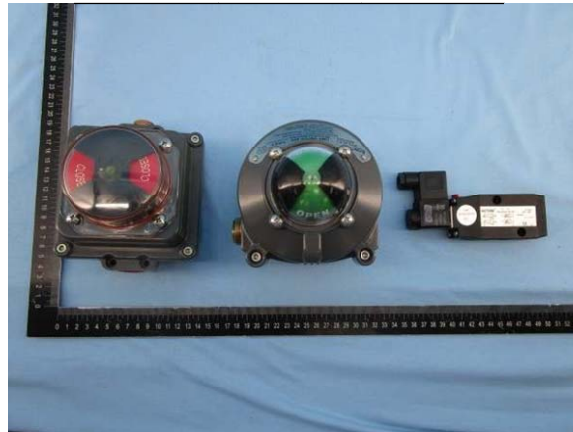
Sample A,B,C

Original Sample Photo:

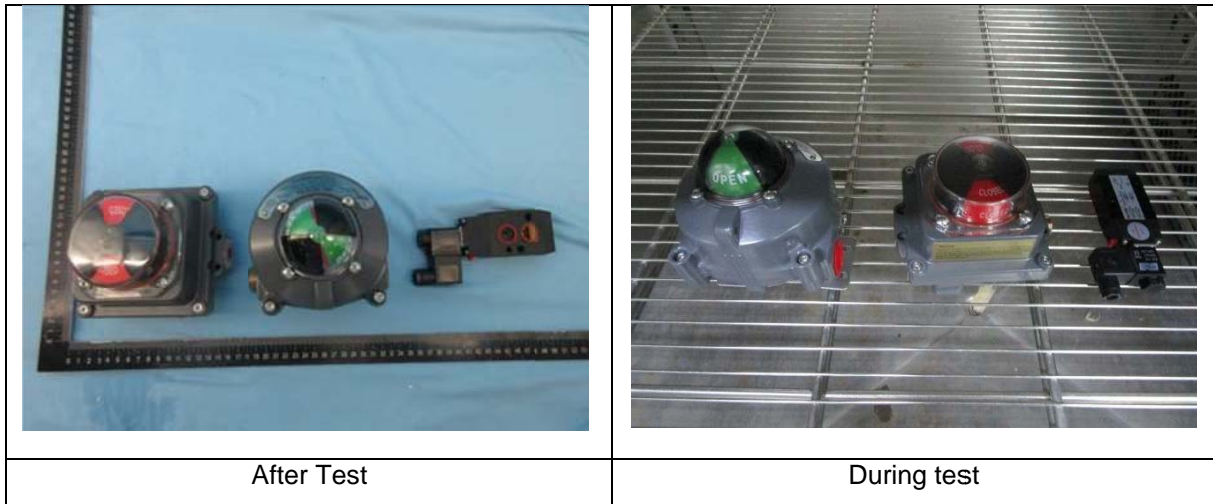
Test Photo:

Test Item 1: Cold Test

Temperature: -40°C

Duration: 72 hours

Sample	Result
A,B,C	No visible change on the samples

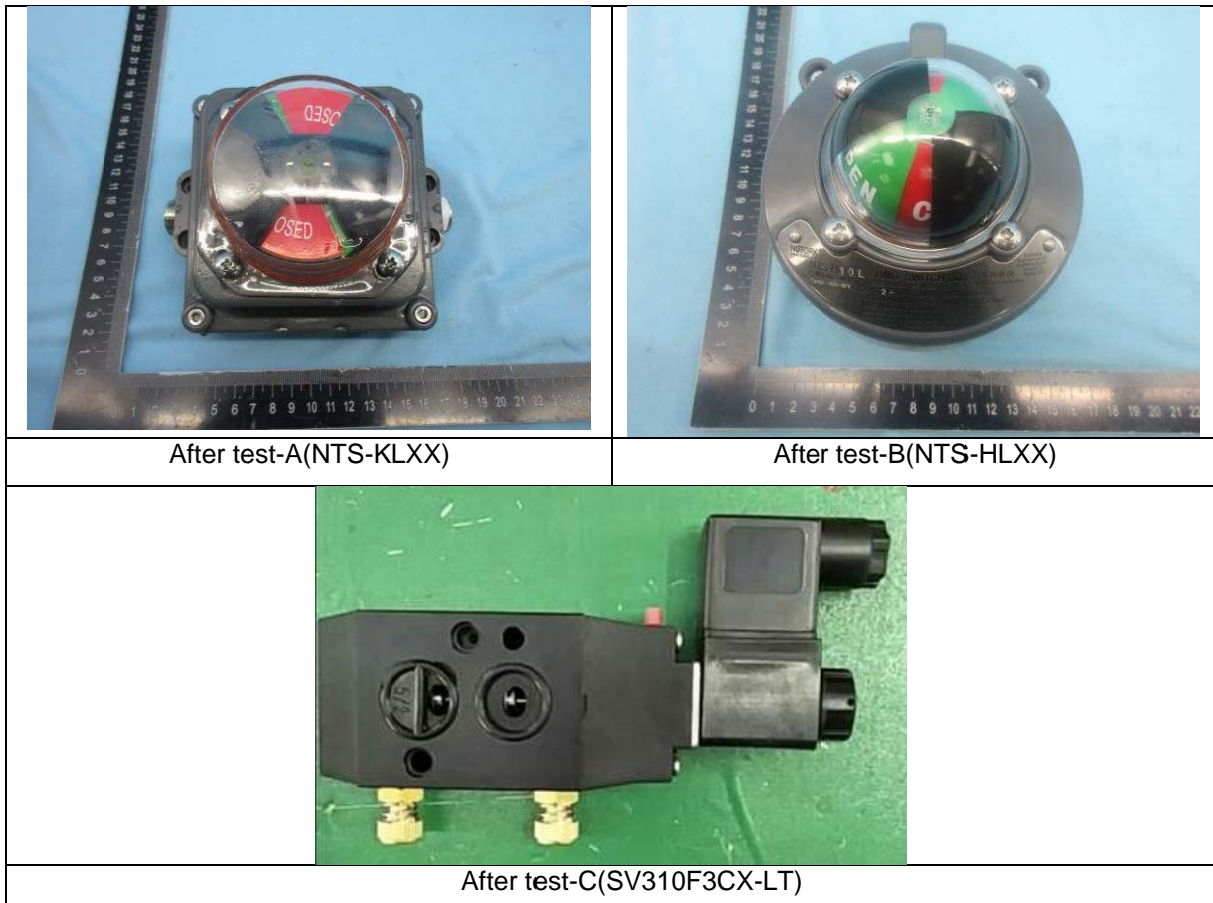
Test Photo:

Test item 2: Air Tightness

Test condition: Smear the suds on the samples and observe if there is a leakage on the surface

Sample	Test result
A(NTS-KLXX)	No visible bubble on the samples, no air leakage
B(NTS-HLXX)	No visible bubble on the samples, no air leakage
C(SV310F3CX-LT)	No visible bubble on the samples, no air leakage
