**Test Report No.: 748204251901**  
**Dated 13-Apr-2015**

**SUBJECT** IP68 Test

**TESTED BY** TÜV SÜD Certification and Testing (China) Co., Ltd.  
Shanghai Branch Testing Center

Sample Name: NTE Series Electric Actuator.

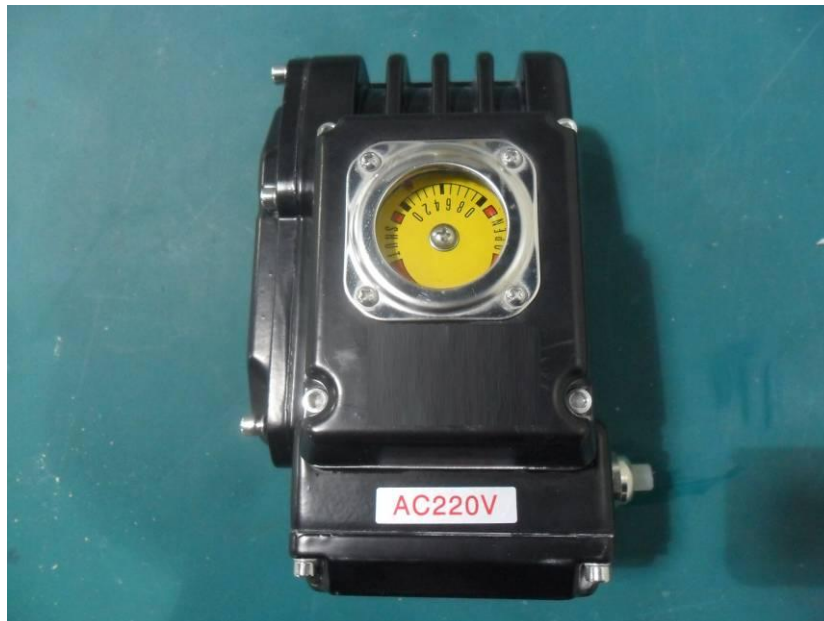
Sample Picture:

Sample Model: NTE-XXX.

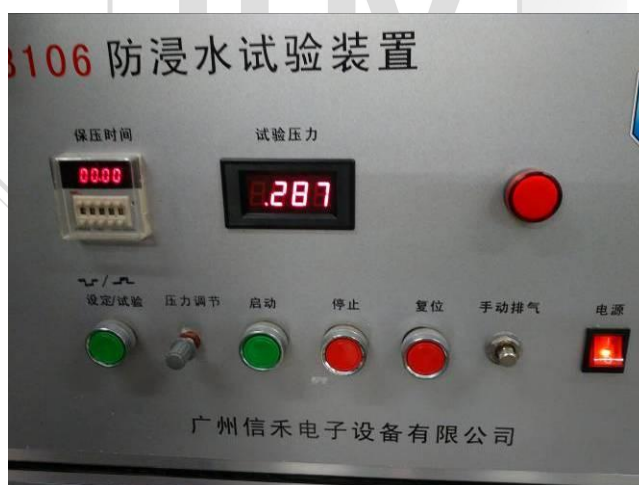
**Test Setup:**

Test methods: According to IEC 60529: 2013.  
 Test conditions:

- The distance of below the surface of water: 1.0 m.
- Test pressure: 0.29MPa (Equal to 30m depth of water).
- Immersion duration: 24 hours.

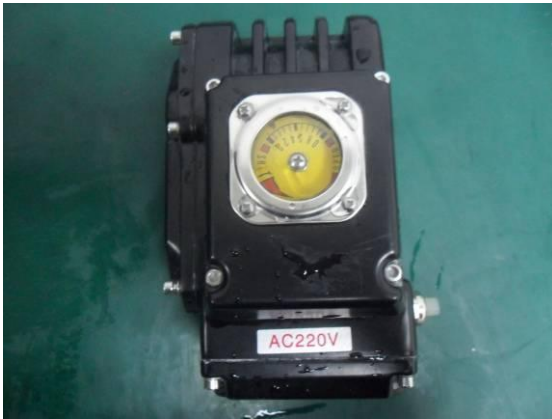
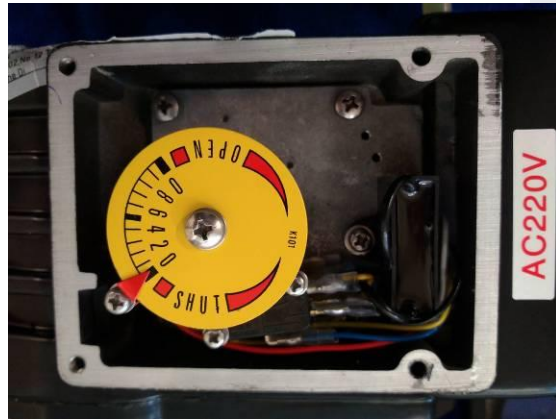
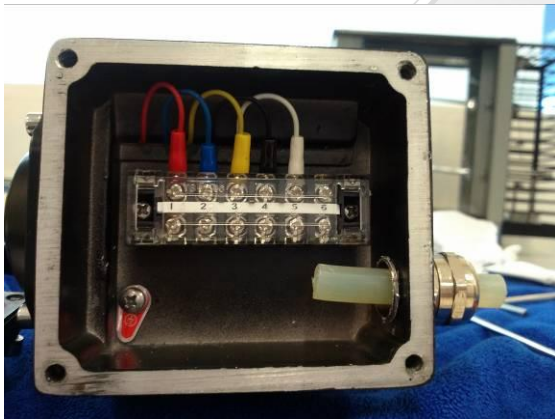
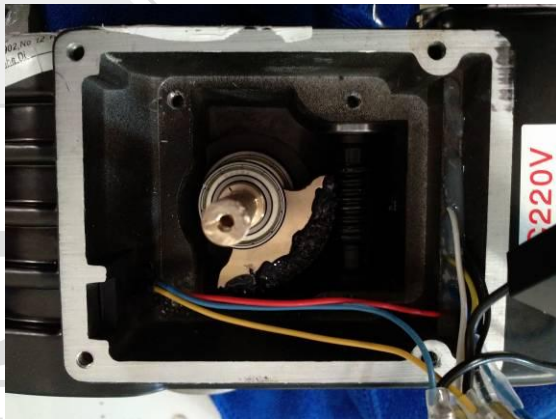
**Appendix 1:** Sample pictures after test.

| Sample No | Test Result |
|---|---|
| 1# | - No water was found inside the enclosure after test. |

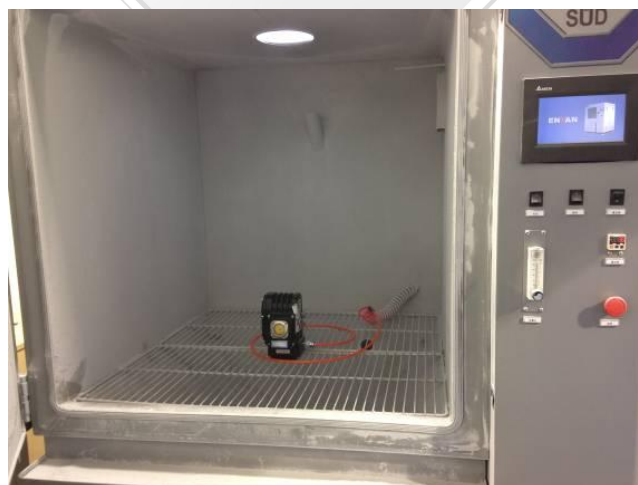
**Test Setup:**

Sample was tested in a dust chamber in which talcum powder is maintained in suspension by an air current. The chamber contains 2 kg of powder for every cubic metre of its volume. The talcum powder used was able to pass through a square meshed sieve whose nominal wire diameter is 50 µm and whose nominal free distance between wires is 75 µm. It shall not have been used for more than 20 tests.

The enclosure of sample is supported inside the test chamber and the pressure inside the enclosure is maintained below the surrounding atmospheric by a vacuum pump.

Test duration is 8 hours.

Pressure inside the enclosure of sample: < 2kPa

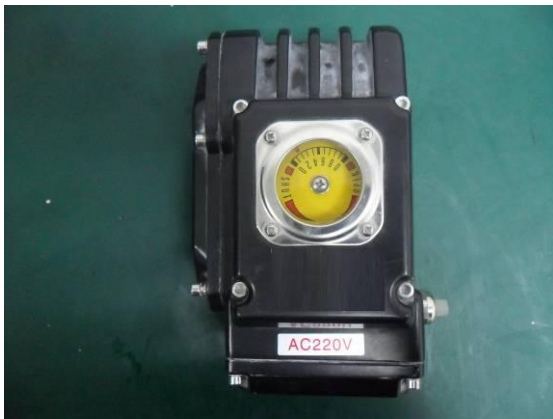
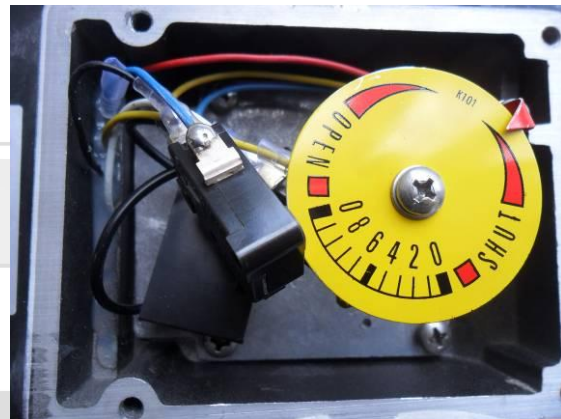
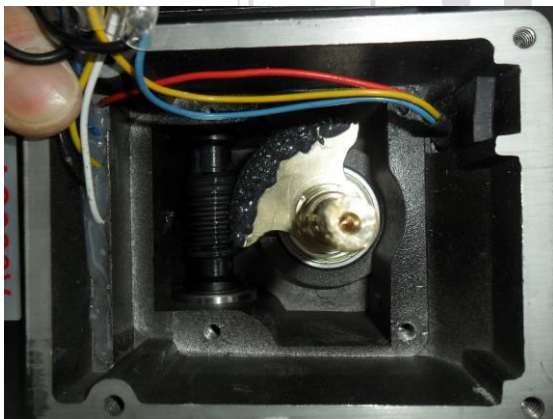
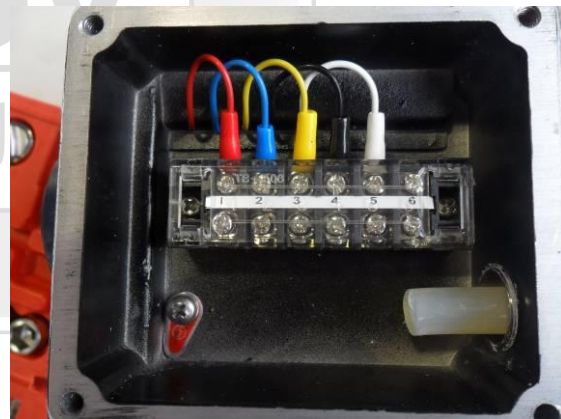
**Appendix 2:** Sample pictures after test.

| Sample No | Test Result |
|---|--|
| 1# | - No dust was found inside the enclosure after test. |
